Appendix VI

Report on Roof Defects (Village Hall)

Roof Defects: The Village Hall, Hall Lane, Blankton, Kent

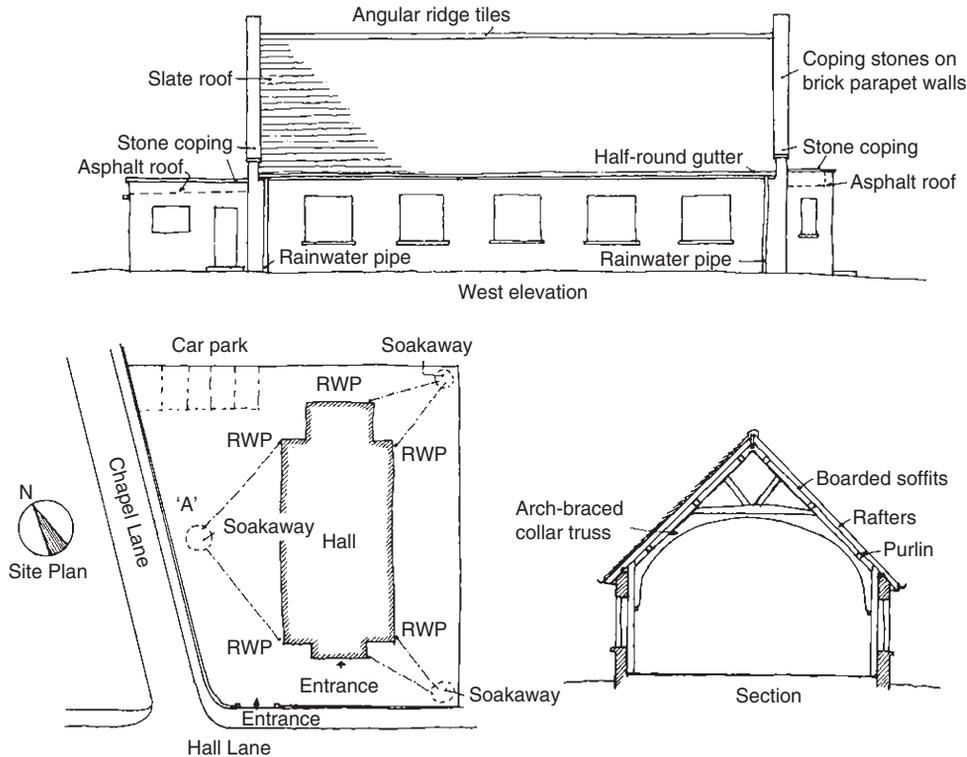
Figure AVI Details of roof and surface water drainage system referred to in Appendix VI

As with many cases of soakaway drainage, the rainwater pipes have been connected direct to the drain with no access. This method has several disadvantages as the condition of the drain is unknown and having no clearing access the silt will gradually build up in the drain and rainwater pipe. This defect is not usually noticed until the rainwater overflows from the next pipe joint up the wall. The usual signs are damp patches on the external wall surfaces. Unfortunately this defect has occurred in three of the rainwater pipes. As agreed the builder exposed the lower section of three of the rainwater pipes and a portion of the drain on the west and east sides of the building. In all cases the drains were completely blocked and out of alignment. The jointing material to the drain pipes has shrunk and cracked and in some places has completely broken away.

We located the approximate position of the soakaways and judging by the subsidence in the ground in that area the soakaways are now ineffective. We removed the top soil to the soakaway marked 'A' on the attached plan and it was found to be in a very poor condition and completely silted up. Experience has shown that any soakaway constructed over 50 years ago is either (a) silted up, (b) collapsed, or

(c) defective due to root penetration. Taking into consideration the age of the system and defects already found it would seem that the whole of the surface water system is in the same deplorable condition. We, therefore, advise that a completely new surface water system be installed. The system we propose will consist of the following:

- a) PVC rainwater shoe fitted with a metal sealing plate for access at the foot of each rainwater pipe. The rainwater pipe being connected to a vertical back inlet.
- b) New 100 mm diameter drains will be required and it is suggested that PVC is used in long lengths to minimise the number of joints (this will reduce labour costs).
- c) Replace the soakaways. It will be necessary to contact the local authority regarding the method of construction and siting in relation to the building.
