Load testing a historic monument

F.D. Heidbrink

Wiss, Janney, Elstner Associates, Inc., Northbrook, Illinois, USA

ABSTRACT: On June 22, 2006, a 230 kg (500 lb) granite fragment fell from the observation deck at the Perry's Victory and International Peace Memorial. The circa 1915 memorial is located on South Bass Island, Ohio. As part of an emergency inspection, the underside of the reinforced concrete Upper Plaza level was surveyed. Extensive and severe freeze thaw deterioration was noted throughout. A load test was conducted to establish whether or not a severely deteriorated portion of the Upper Plaza can safely and reliably support the code prescribed loads with an appropriate factor of safety. At the conclusion of the test, one of the beams did not meet the acceptance criteria. Therefore, after long term repairs to the memorial are completed and public access to the plaza restored, it was recommended that the live load rating be reduced, that the Upper Plaza be shored or reinforced, or that the Upper Plaza be demolished and rebuilt.

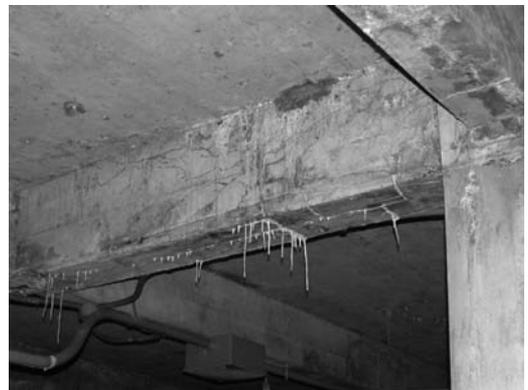
the reinforced concrete structure. Three cores were removed for examination for freeze-thaw deterioration. One of these cores was tested for compressive strength. Notable conditions observed included concrete deterioration in the form of cracked, spalled, and delaminated concrete. Some areas of concrete sounded "dead" or hollow when tapped with a hammer, indicating delaminations, freeze-thaw deterioration, or other defects. In areas of spalled concrete, corroded reinforcing steel was observed. Areas of previously installed patches were noted. Sound testing of the previous repairs indicated that some areas may be delaminated and/or debonded. Evidence of water leakage through the deck structure in the form of water staining and efflorescence was observed on the underside of the structural slab (Fig. 3).

Figure 3. Extensive and severe freeze-thaw damage to underside of Upper Plaza.

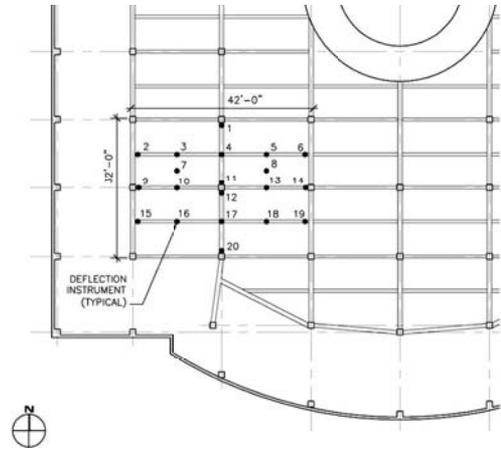
Deflections of the beams and slab areas were monitored using cable extension transducers (CET) installed at twenty locations. Figure 4 is a plan view showing the locations of each installed instrument. Each CET has a measurement range of at least 50 mm (2 in) with a resolution of 0.025 mm (0.001 in). The CETs were wired into a panel board, which was interfaced to a data acquisition system.

Figure 4. Plan view of deflection instrument locations.

Of the six reinforced concrete beams tested, load testing showed that one of the beams did not meet the ACI criteria for both maximum deflection and residual deflection. The center of the beam at CET 13 had a maximum deflection of 5.4 mm (0.212 in), which exceeded the calculated deflection limit of 3.7 mm (0.147 in). In addition, CET 13 had a residual deflection of 1.6 mm (0.063 in), which exceeded 25 percent of the maximum deflection, or 1.3 mm (0.053 in). The beam at CET 13 was not observed to have distress conditions present based on the visual survey.

Of the two reinforced concrete girders tested, CET 4 had a maximum deflection of 2.8 mm (0.110 in), which exceeded the calculated deflection limit of 1.7 mm (0.068 in). However, CET 4 had a residual deflection of 0.7 mm (0.027 in), which did not exceed

25 percent of the maximum deflection and therefore met the acceptance criteria. The girder at CET 4 was observed to have been “dead” or hollow sounding based on the visual survey.

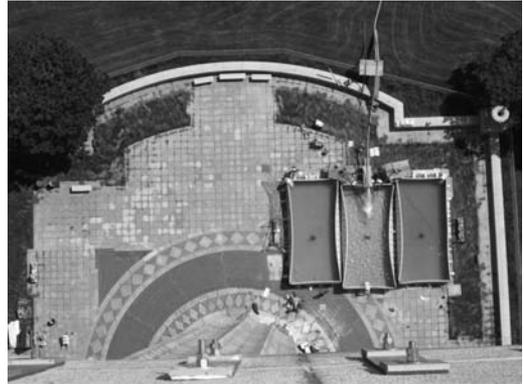
Figure 5. View of load test in progress looking down from the observation deck (note repairs to observation deck facade).
