9 Timber Decay and Insect Attack

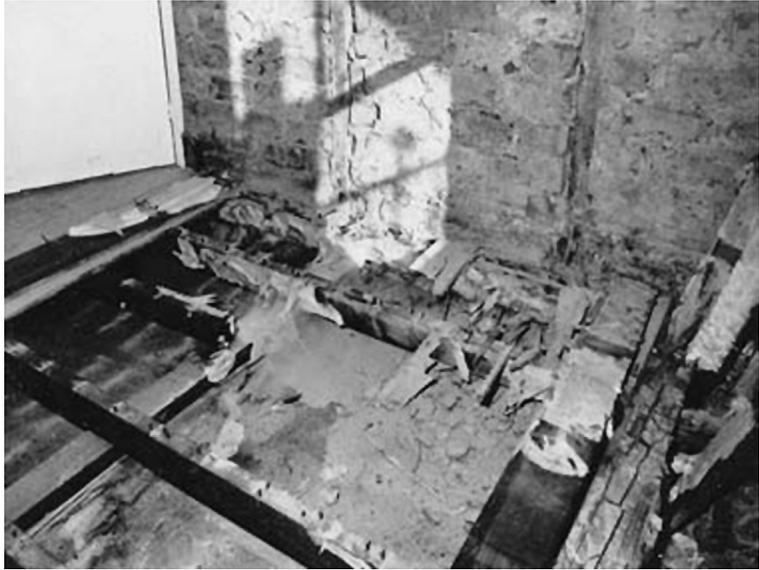
Figure 9.1 Dry rot spore dust in floor joists and partition. Reproduced by permission of Harsco Infrastructure

In the first case described above the ground floor construction is the most likely place for dry rot to appear. The construction consists of timber joists supported on sleeper walls built of the site concrete. If the sleeper walls are well provided with honeycomb openings, and the external walls have enough air vents, the circulation of air may be sufficient to carry away the moisture and so prevent the fungus starting. However, it often happens in course of time the air vents become clogged or covered with earth (see Chapter 8). Pockets of stagnant air and rising damp through poor quality site concrete or brickwork are the primary contributory causes of fungal decay. The timber will absorb the moisture and so produce the fungi which decompose the wood. Figure 9.1 shows ground floor joists badly affected by dry rot attack.

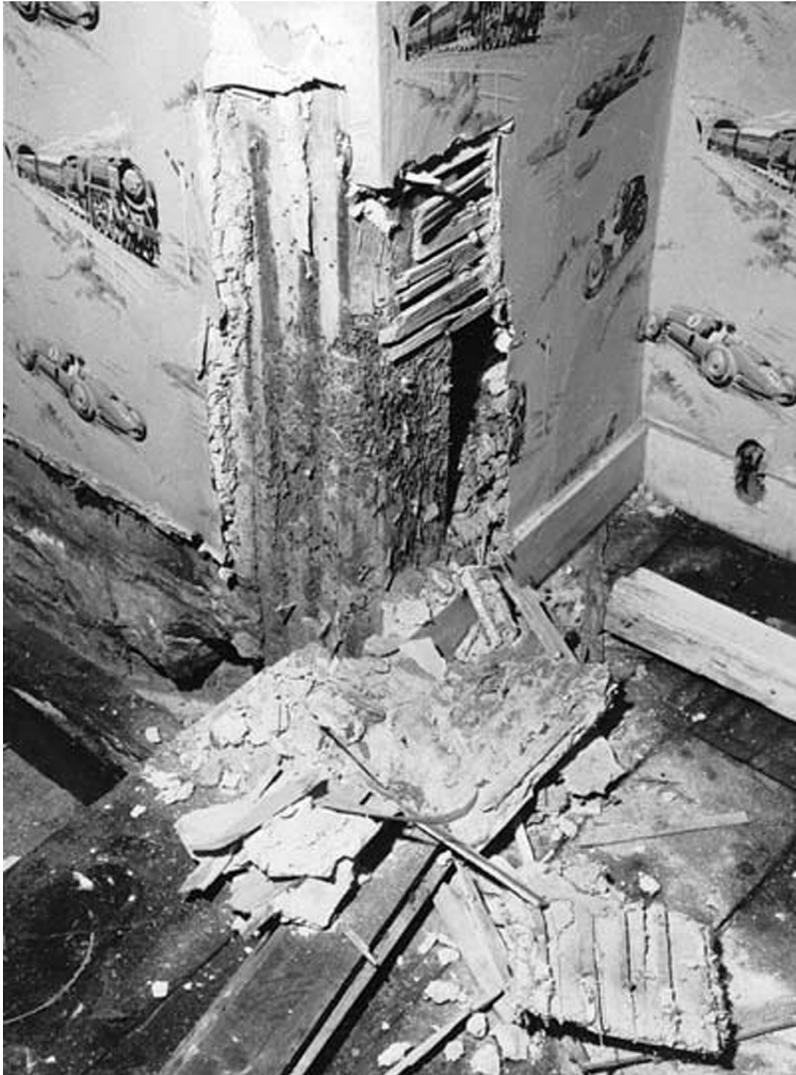
Figure 9.2 Effects of death watch beetle. Reproduced by permission of Harsco Infrastructure

old hardwoods, usually oak and chestnut, and most damage occurs in built-in parts of a structure such as end beams, wall plates and poorly ventilated places (Figure 9.2).
