Appendix VII

Report on Property to be Purchased

Property survey: No. 10 Orchard Road, Blankton, Kent

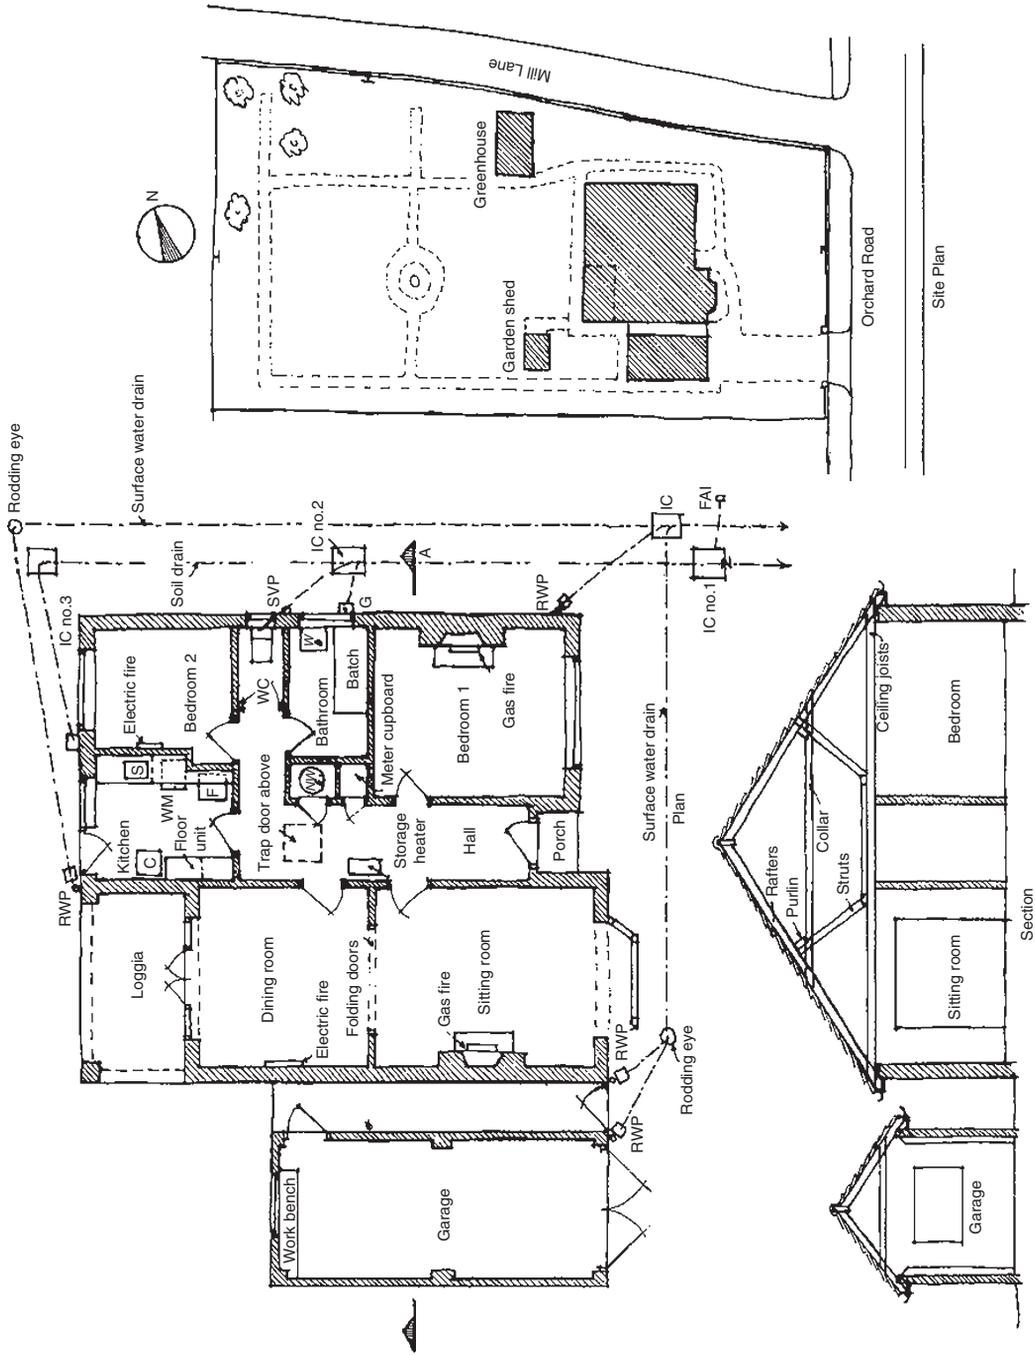
Figure AVII Plan of detached bungalow referred to in the report (Appendix VII)

In the following accommodation list the first dimension in each case is parallel to the frontage (see sketch plan attached).

The kitchen and bathroom are heated by wall mounted infrared heaters with pull cord switching. The heat output is 1.8kW. The dining room and bedroom 2 are heated by electric panel fires secured to the wall in the positions shown on the sketch. Both these appliances are fairly modern and are in serviceable condition.
