12 Timber Upper Floors, Floor Coverings, Staircases and Ladders

12.1 Introduction

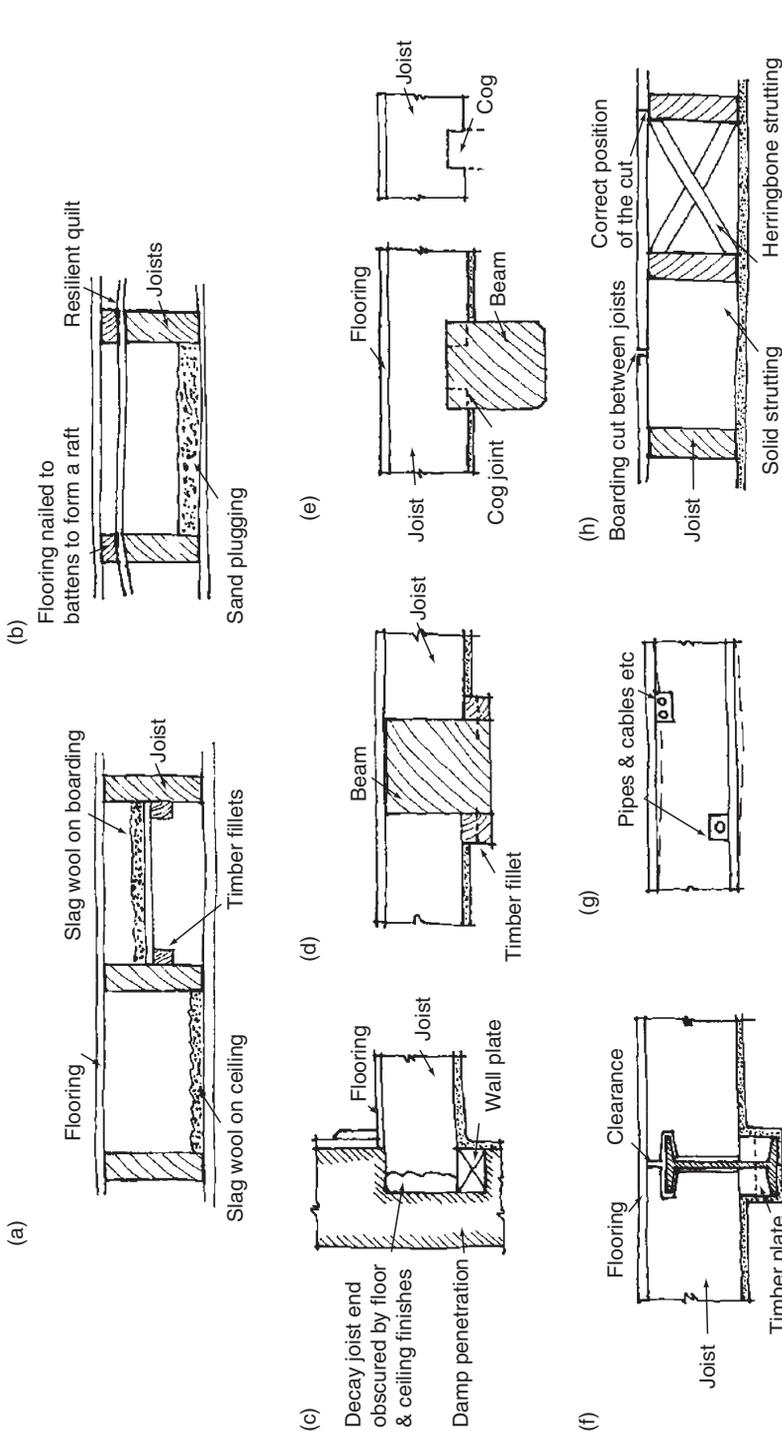
Figure 12.1 (a) Two methods of sound insulation between floors. (b) 'Floating floor' for sound insulation. (c) Joists built into solid wall without an air space. (d) Joist resting on fillets nailed to bottom edge of beam. (e) Method of cogging joists over timber beam. (f) Typical notching when RSJs are used. (g) Floorboard jointing and strutting details. (h) Floorboard jointing and strutting details

After removing some sections of the floor boarding it is fairly easy to recognise the various types of insulation to enable a report to be prepared. A simple method is a layer of slag wool about 75 mm thick resting on the ceiling below as shown on the left-hand side of Figure 12.1a. A better method which is often found in business premises is shown on the right-hand side of Figure 12.1a and consists of an air space above and below the wool. The wool is supported on boarding which is in turn secured to the joists by timber fillets. A third method is shown in Figure 12.1b and consists of a heavy plugging of sand on the ceiling with a resilient quilt draped over the joists known as a 'floating floor'. The principle underlying the design of a floating floor is its isolation from any other part of the structure. It is, therefore, important to ensure that the flooring is nailed to the battens to form a raft and not nailed through to the joists. The floor must also be isolated from the surrounding walls. These are points which require checking during the examination.

- (3) As mentioned in Section 12.1 the joists in double floors rest on timber beams or RSJs to reduce the span and the manner in which they do so depends on the type of workmanship that has been put into the construction. A bad form of construction which is sometimes found in older buildings is a fillet nailed along the bottom edge of the beam with the joist resting on the fillet as shown in Figure 12.1d. In such cases the nails in the fillets are supporting the joists and if they should fail the joists would collapse. When carrying out an investigation to such a floor, it may be found that the nails have given a little, but not necessarily caused a dangerous condition. If this is so the floor

can be strengthened. It is better practice to cog the floor joists over the beam as shown in Figure 12.1e. Figure 12.1f shows a typical notching where the beam consists of a rolled steel joist. The timber joists are supported on timber plates secured to the web of the RSJ, but are kept clear of the rest of the RSJ to allow for expansion and contraction of the timber. In some cases the top of the joists are flush with the top of the RSJ causing the floorboard situated over the top flange to curl due to the fact that the only fixing is the tongue and groove in the jointing of the floorboard.

- (5) The centre of the span should be checked for some form of strutting. Although strutting is usually fitted between joists, it may happen that in very old timber floors it has been omitted, in which case undue vibration will occur. This is due to the joist tending to tip sideways under movement, especially if the floorboards have not been nailed to every joist. Also the end wedges between the wall and the last joist may have been omitted or have fallen out. If this is the case, considerable improvement can be effected by taking up the flooring and inserting a row of solid strutting down the centre of the span (see Figure 12.1h).

- (6) Another problem which could be attributed to deflection in old floor joists is that excessive notching of the joists may have been made to accommodate gas pipes, electrical cables or water pipes (see Figure 12.1g). If the surveyor feels uncertain on this point it is well to consult the British Standard Code of Practice BS 5268-2: 2002 which sets out rules concerning safe notching in joists.

The surveyor will sometimes find that the ends of the boards meet between joists forming a cantilever as shown on the left-hand side of Figure 12.1h and will spring under weight. The cut should be made at the middle of the joists as shown on the right-hand side of Figure 12.1h.

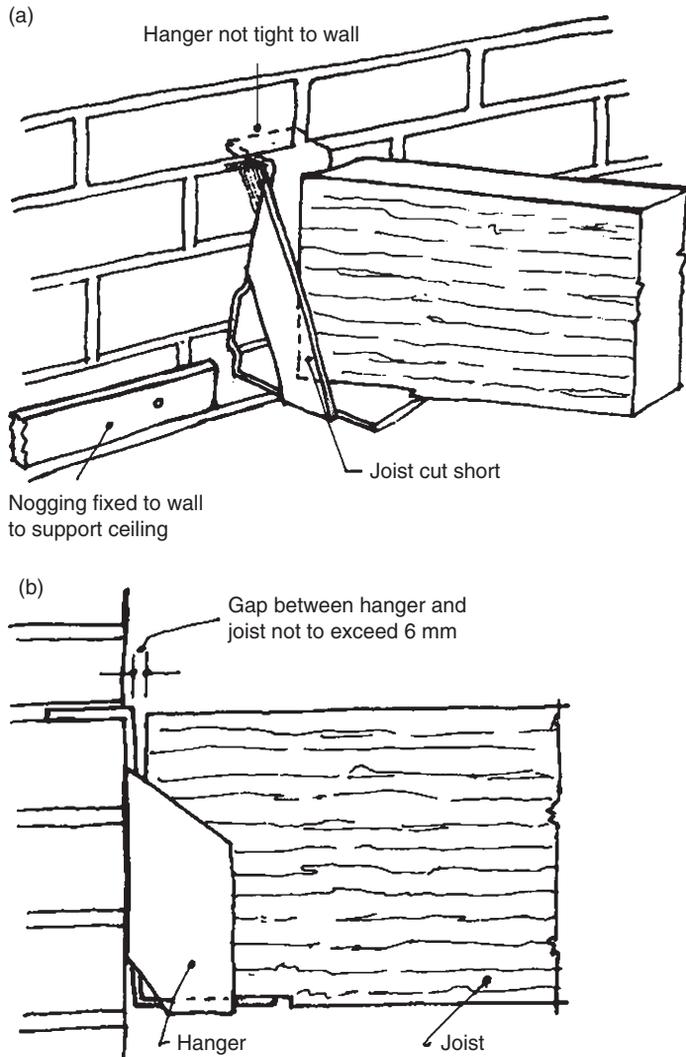
Figure 12.2 Use of metal joist hangers: (a) incorrect positioning; (b) correct positioning

- (8) In modern properties metal joist hangers have been used extensively. Unfortunately, recent surveys have found instances where the hangers or joists have failed due to one or more of the following causes (see Figures 12.2a and b).

- Hangers should be tight against the face of the masonry.
- Incorrect grade of hanger used. It is important that hangers are not used with masonry of lower strength than the hanger grade marking. Hangers should comply with BS 6178 Part 1 and are made for minimum masonry crushing strengths.
- Sometimes joists are cut short leaving a large gap between joists and back plate of hanger. This may cause hangers to move and the floor to settle.
- Check to ensure that no damaged or corroded hangers have been used.
- Check that the undersides of the joists are properly notched to accommodate the hanger flanges.
