8

Damp Penetration and Condensation

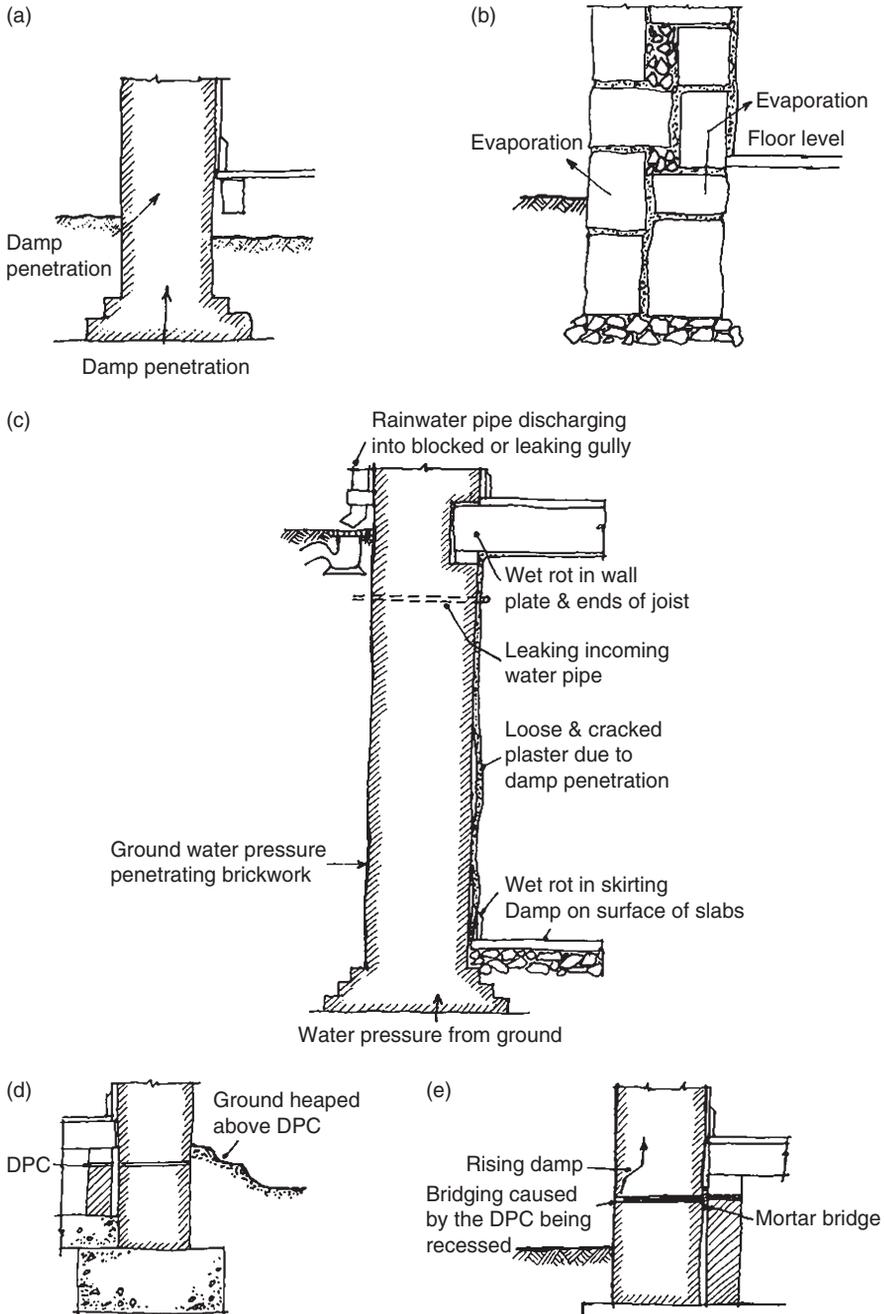
Figure 8.1 (a) Typical early nineteenth century external wall construction with no DPC. (b) Traditional solid stone wall. No DPC. (c) Typical damp problems in old basement walls. (d) DPC covered by earth. (e) Defects caused by bridging DPC

As mentioned in Section 8.1 the ground around the foundations is often damp; moisture rises into the brick or stonework by capillary attraction and unless a DPC is provided above ground level the moisture can rise, causing considerable dampness to walls and floors. It is, therefore, important that the surveyor makes a careful examination of the base of the wall to ascertain the existence or absence of a DPC. If there is no damp course, dampness will show along the bottom of both external and internal faces causing discoloration, mildew and peeling decorations. The damp will rise in a wall or partition to a height at which there is a balance between the rate of evaporation and the rate which the damp can be drawn up by capillary attraction. The line of dampness due to the absence of DPC is usually continuous and fairly horizontal and in severe cases can reach a height in excess of 1 m (see BRE Digest 245). Figure 8.1a shows a typical early nineteenth century external wall construction with no DPC and no foundation concrete.

The important point for the surveyor to remember is that any treatment which prevents evaporation such as waterproof rendering internally or externally, will only cause the damp to rise higher before it can evaporate, causing more problems (Massari & Massari, 1993)! Any treatment recommended (Burkinshaw, 2009) is a matter requiring careful judgment (see Figure 8.1b).

Flag stones or brick floors were usually laid on the bare earth and moisture rising from the ground is common. The surveyor will often find an impervious finish has been laid over the solid floor which has become very wet underneath, and probably affected by rot. Figure 8.1c shows typical problems in an old basement wall.

A common defect is where the horizontal DPC is placed nearer the ground than the 150 mm clearance required by the Building Regulations, and becomes ineffective through being bridged by earth or paving slabs laid at a higher level (Howell, 2008). In wet weather moisture may be drawn into the wall from the soil above the DPC. Where dampness appears on the interior face near the floor, the ground level in relation to the DPC should be examined (see Figure 8.1d).

Rendered plinths were common during the early part of the twentieth century, often in speculative built houses. In many cases the plinths were applied to buildings with solid walls and they invariably bridged the DPC causing rising damp to penetrate through to the wall plaster and skirtings. Bridging can also be caused by the DPC being slightly recessed and the joint filled with pointing mortar as shown in Figure 8.1e.

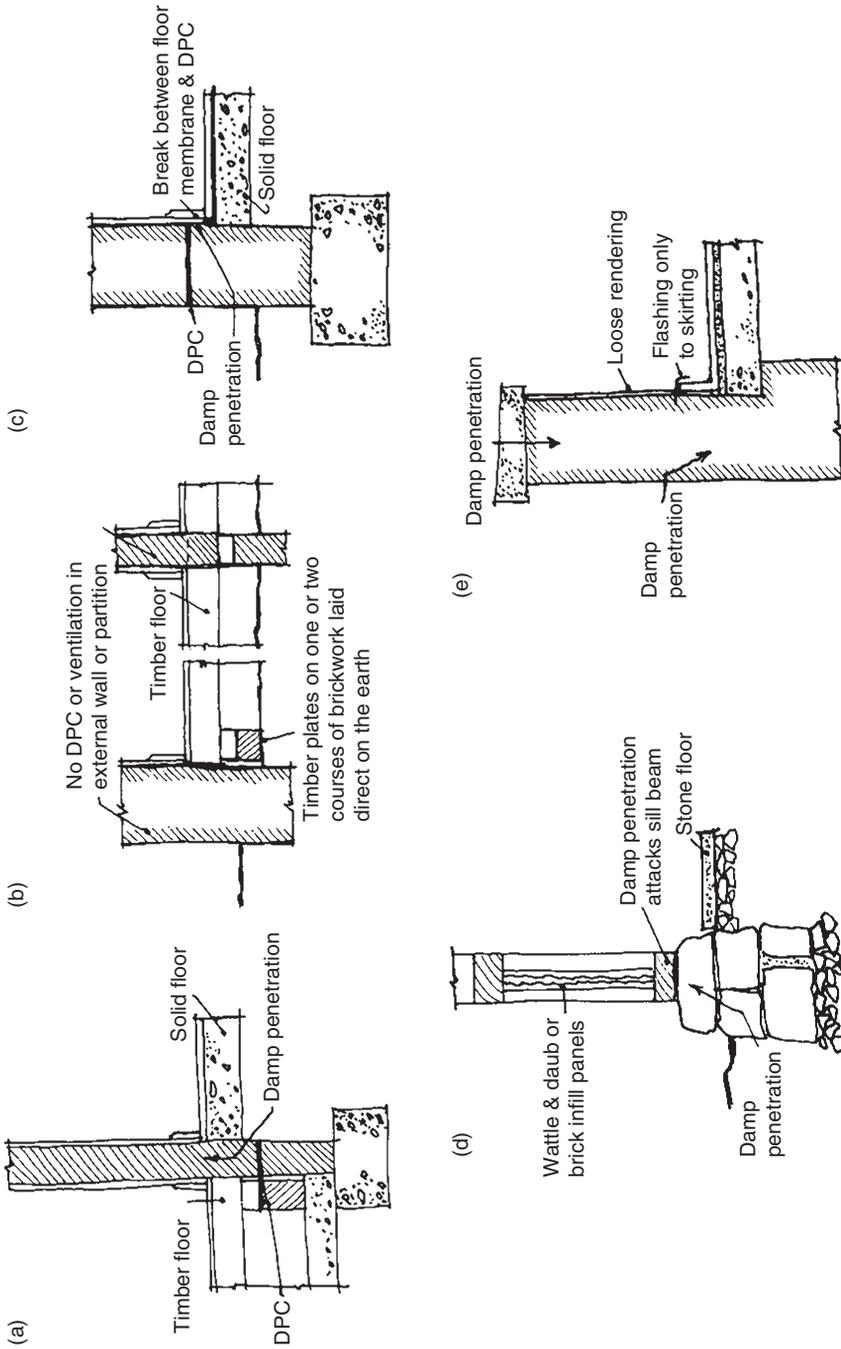
Figure 8.2 (a) Incorrect DPC insertion in partition wall. (b) Typical early nineteenth century timber floor construction. (c) Inadequate jointing between floor membrane and DPC. (d) Typical base detail of timber framed building. (e) Defects caused by the absence of DPCs in parapet wall

Another common defect found in domestic property is a partition wall with a solid floor on one side and a joist floor on the other. If the DPC is a few millimetres below the concrete floor then damp can rise through the unprotected gap (see Figure 8.2a).

The ventilators were often small and insufficient in number, but they did allow a certain amount of air to circulate around the joists. DPCs consisting of slates are likely to be found below the wall plates of sleeper walls during this period. In both the above categories very few will be found to have been provided with site concrete (see Figure 8.2b).

A number of damp-proofing materials have been developed over the past 60 years providing a completely impervious membrane over the solid floors. Any failures that may occur in the damp-proof membrane are usually due to inadequate jointing with the external wall damp course. It is essential that the damp-proof membrane is continuous with the DPC in the external wall. It is under such circumstances as these that the moisture meter is of great assistance, and in order to determine accurately the cause of the defect it will probably be necessary for the surveyor to obtain the owner's permission to remove a portion of the skirting and expose the internal face of the wall. If moisture can be found to have affected the walling behind the skirting the cause can only be due to inadequate jointing between the floor membrane and the DPC in the external wall (Figure 8.2c). An important point to check is the air space and ventilation to the ground floor. This space must be properly ventilated to protect the joists and wall plates against dry rot. Air is induced from outside by the insertion of air vents at frequent intervals immediately under the damp course level (giving at least 1500 mm² fresh air inlet per lineal metre of external wall). The air vents are usually constructed of cast-iron or terracotta (size 230 mm × 75 mm) although tile slips are often used in good quality work. It is not unusual to find that the air vents have been covered with perforated zinc or even solid metal plates in order to discourage insects or mice. When carrying out the examination it is important to ensure that the air vents are free from obstruction. If close to garden planting or shrubs the apertures are often found to be filled with earth.

The external faces of the parapet should be carefully examined. If the bricks show signs of decay or surface flaking this will indicate that the wall is saturated and frost damage or sulphate attack has occurred. Cracks or bulging of any rendering either on the internal or external faces will also indicate severe damp penetration. These defects are usually caused by the absence of a DPC below the coping (see Figure 8.2e).

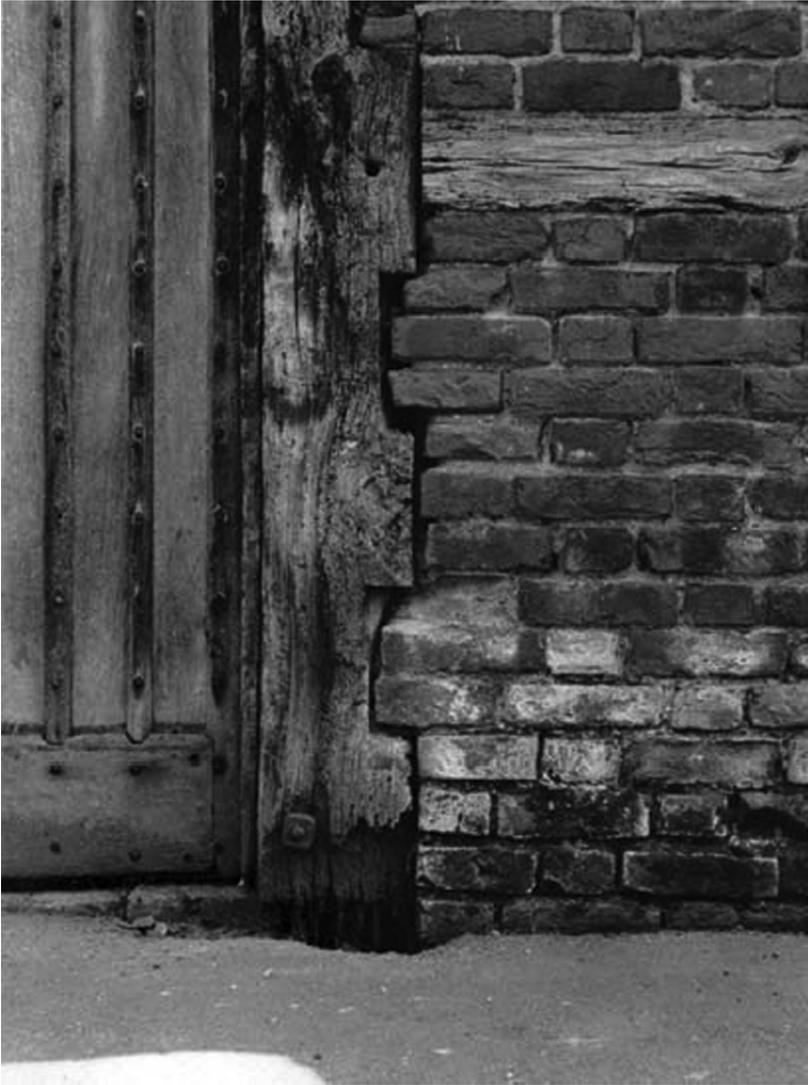
Figure 8.3 Effects of rising damp and woodworm in a timber-framed building

Damp penetration in framed buildings also occurs at the joints between the panel infilling and the timber framing. The systems usually consist of cracks between the frame and the panel infilling allowing rainwater to penetrate. Distortion of the frame is also a common defect resulting from twisting and warping of the timber over many years. Figure 8.3 shows the effects of rising damp and woodworm at the foot of a timber post in a timber framed building.

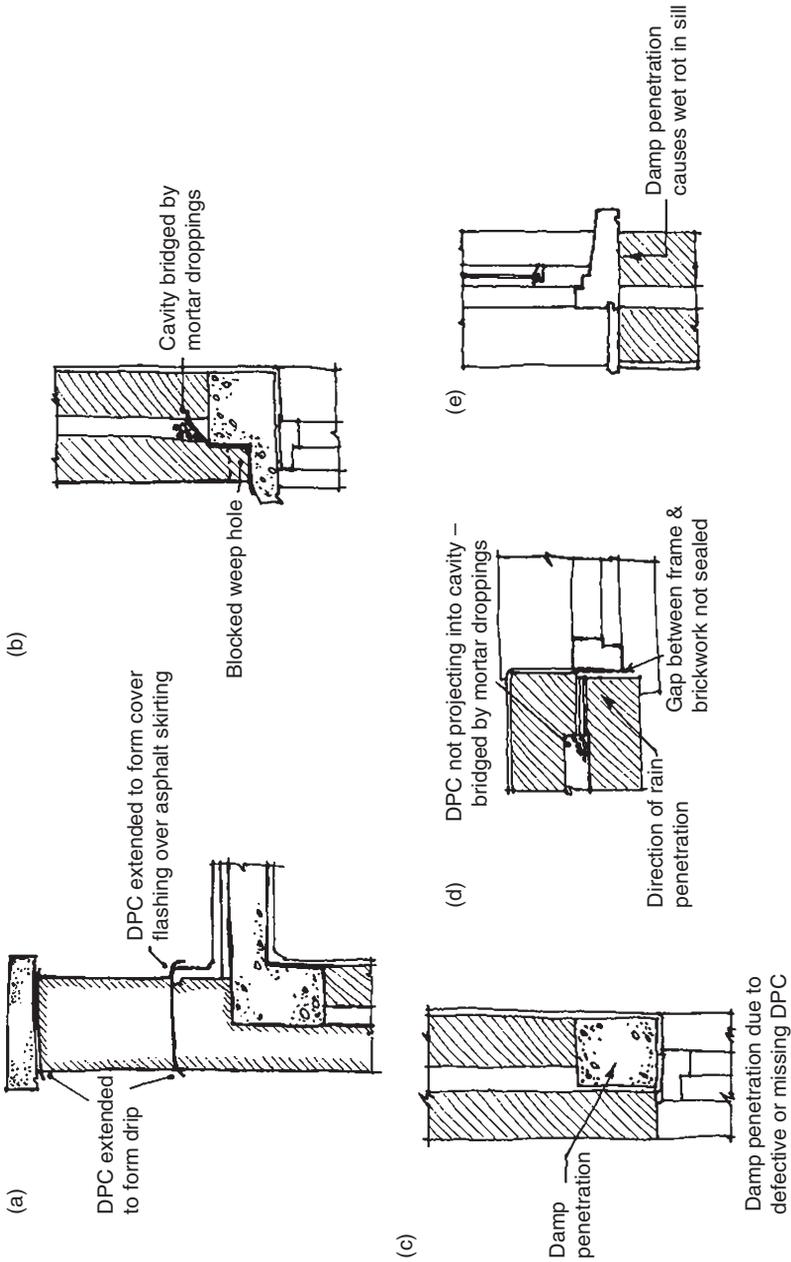
Figure 8.4 (a) Correct detail for DPCs in solid parapet wall. (b) Bridging of DPC over opening. (c) Damp penetration due to defective or missing DPC. (d) Damp penetration due to poor detailing of DPCs and jointing to reveal opening. (e) Damp penetration due to omission of DPC under sill

The next point to investigate is the provision of a DPC under the coping and in the parapet wall at the top of the skirting to the roof. If these DPCs are missing or ineffective then damp will penetrate through the main fabric of the structure. A common defect found in a number of parapet DPCs has been to stop the DPC short of the internal brick face and not turn it down. On a flat roof the DPC should be taken right through to the internal face of the parapet to form a cover flashing over the skirting as shown in Figure 8.4a. On the external face, the DPC should extend to form a small projecting drip on the face of the brickwork. If the wall is rendered externally the DPC should pass through the thickness of the rendering and be turned down to prevent 'bridging' of the damp course by the rendered face.

is also a common fault with DPCs over window and door openings as shown in Figures 8.4b and c where bridging of the cavity is caused by excessive mortar droppings building up off the DPC or due to a faulty or missing damp-proof tray. Damp patches on the plaster about 300 mm above the head of the window usually indicate mortar droppings collecting at the head of the damp-proof tray. The weep holes externally should also be examined to ensure that they are not blocked.
